SAFETY BULLETIN SB03-002B

Subject: Cab boom Failure.

Unit/Part Affected: Cubex QXR – All Models.

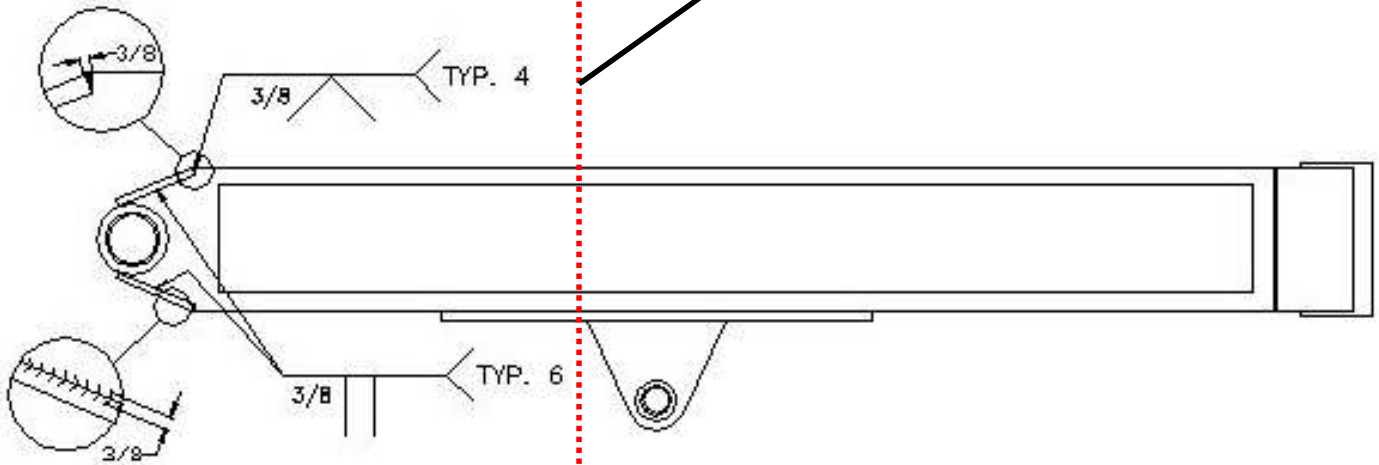
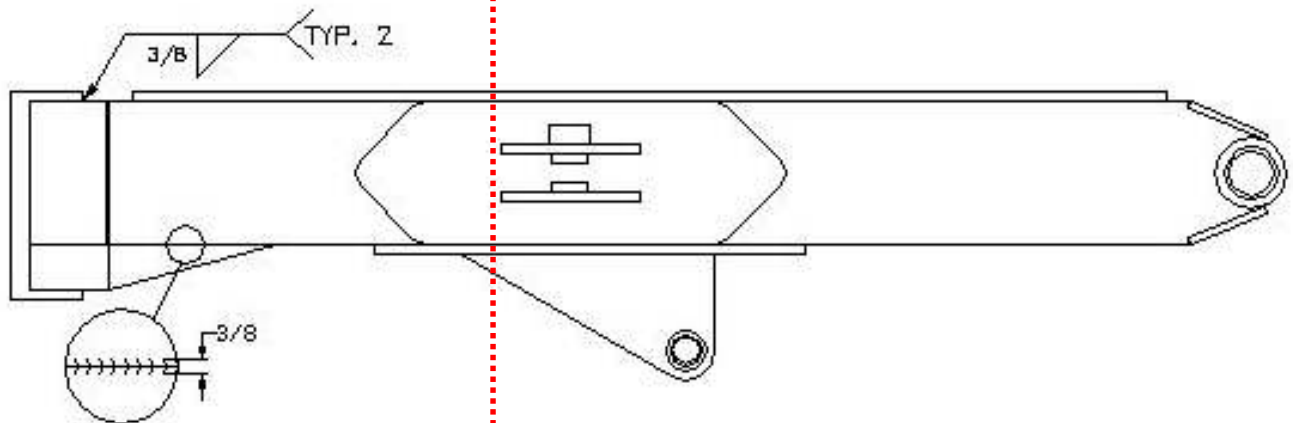
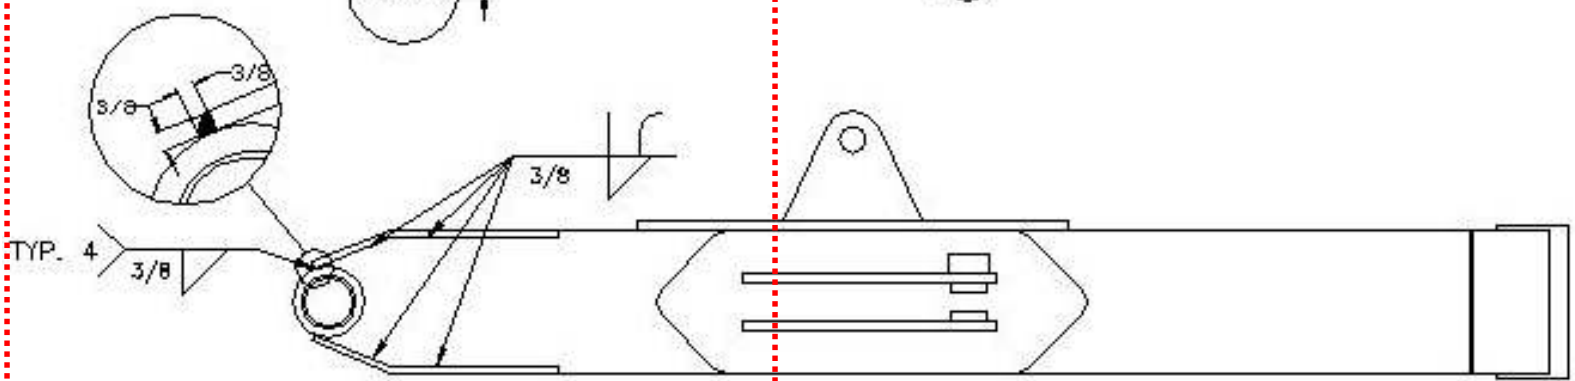
Area of Concern

Brief Description of Incident: A failure occurred in the boom on the end where it connects to the unit. The failure can be attributed to the cab boom not being welded in accordance to Cubex engineering specifications. This is an isolated incident that happened within the first 70 hours of operation.

The cab boom is to be inspected by your local Cubex dealer and welds are to conform to the specifications shown on the next page.
